# Inspection Report

456 Sample Dr.  
Jackson Tn. 42066

**Town and Country Property Inspections**

<b>Date:</b> 9/24/2015	<b>Time:</b> 11:00 AM	<b>Report ID:</b> 092415
<b>Property:</b> 456 Sample Dr. Jackson Tn. 42066	<b>Customer:</b> Mr. and Mrs. John Smith	<b>Real Estate Professional:</b>

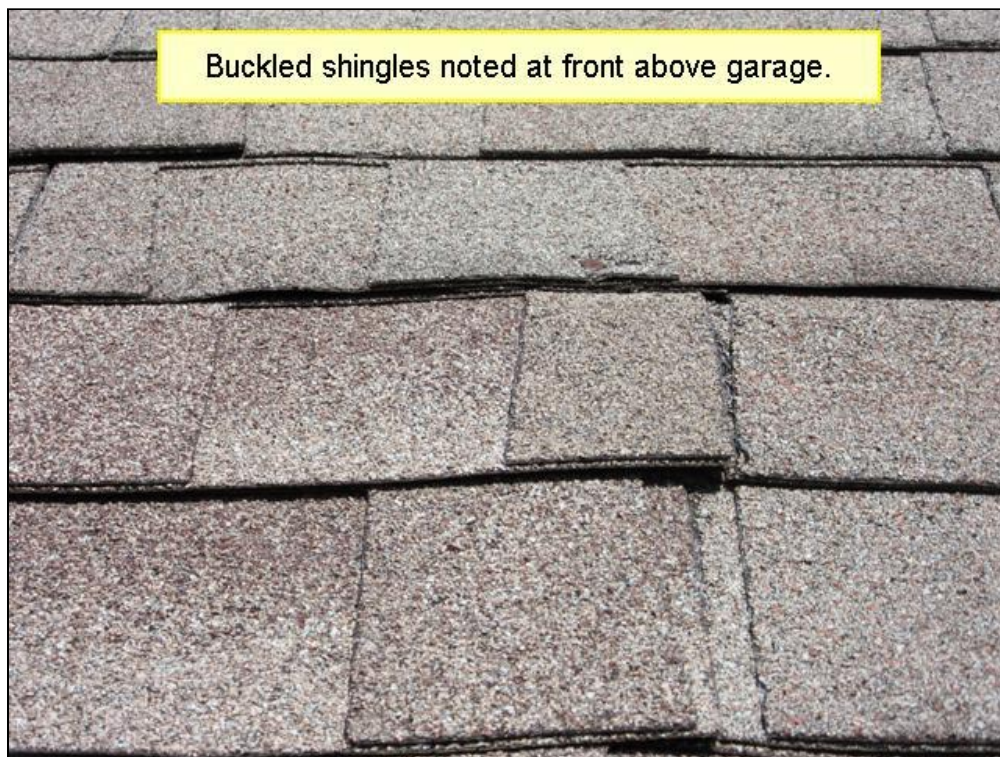
1.0 Item 1(Picture)

**1.0** Roof covering consist of a architectural composition type shingle. The roof is in overall fair / good condition with no active leaks noted. However an exposed nail head was noted and tar has been used to repair an area as well. One shingle was loose and has slid down from its original position and some buckling was noted at an area above garage. Recommend qualified roofer evaluate for repair or replacement.

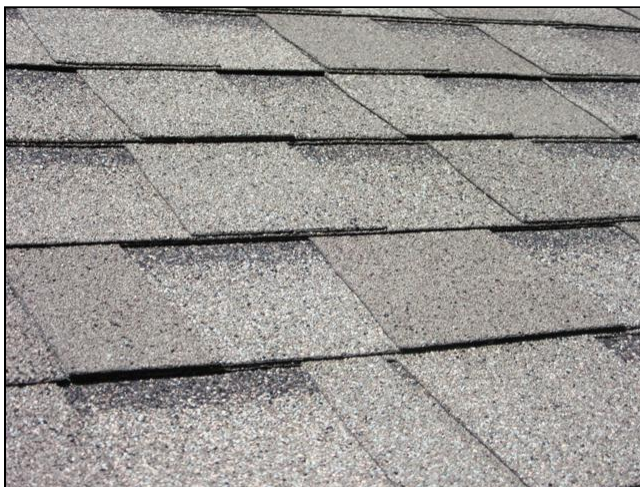
1.0 Item 3(Picture) Close up at rear.

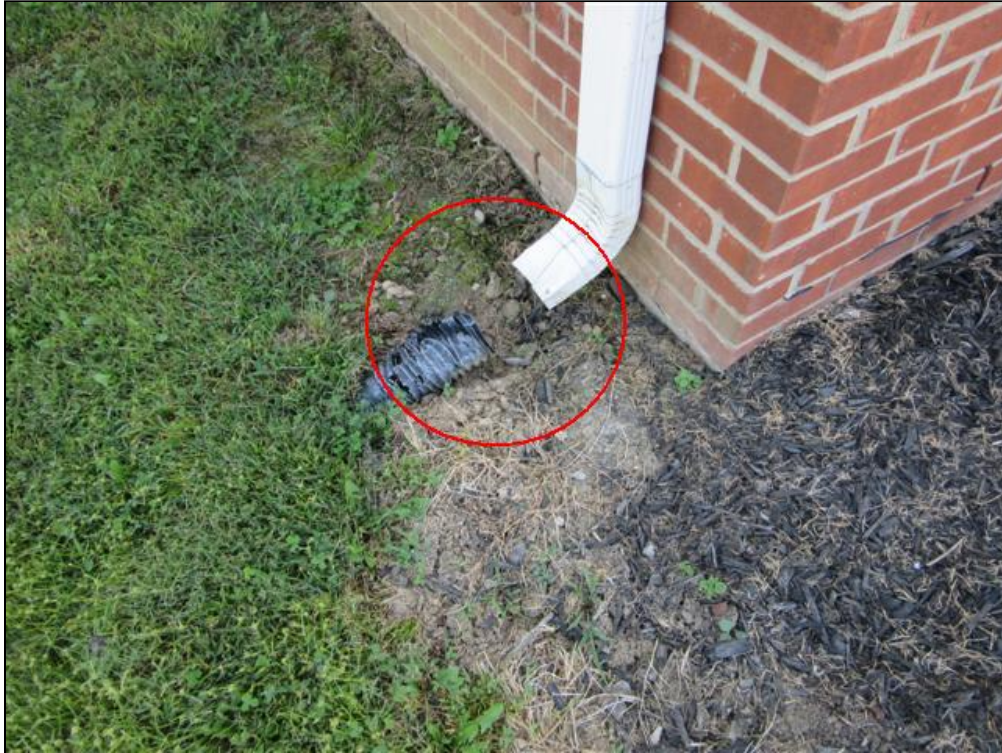
**1.3** Gutter downspout extensions are recommended to help route excess rain water away from foundation. Some downspouts use an underground drain system and the areas where they terminate should be kept unobstructed to allow excess rain water to flow as intended.

1.3 Item 1(Picture) Downspout disconnected.

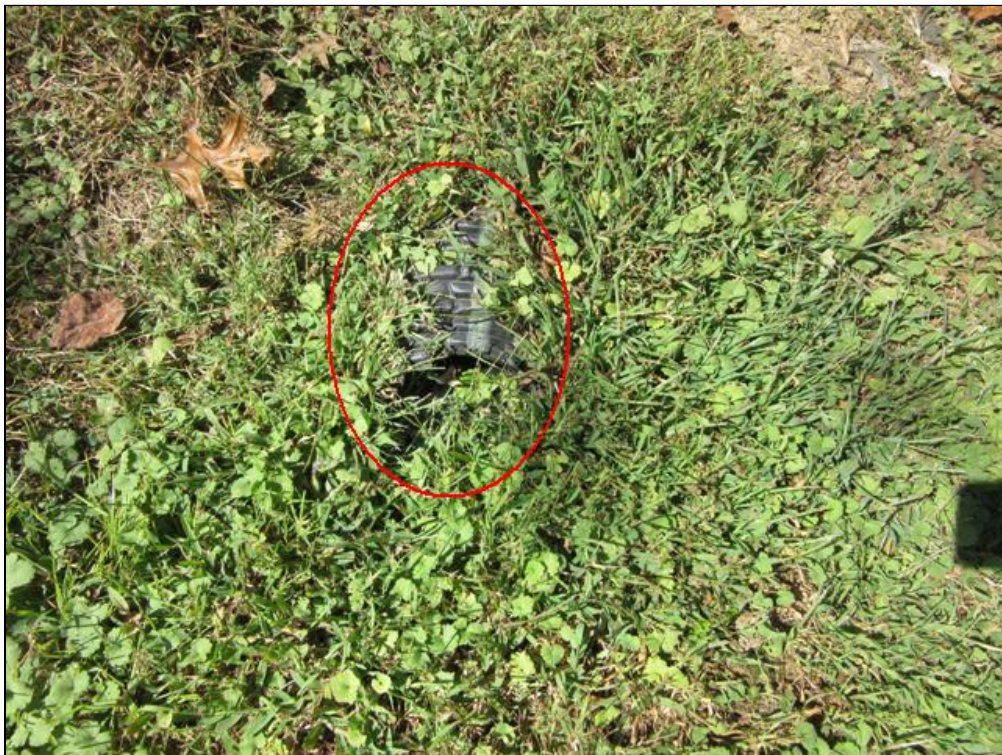
1.3 Item 2(Picture) Buried gutter downspouts should be opened and allow water to flow as intended.

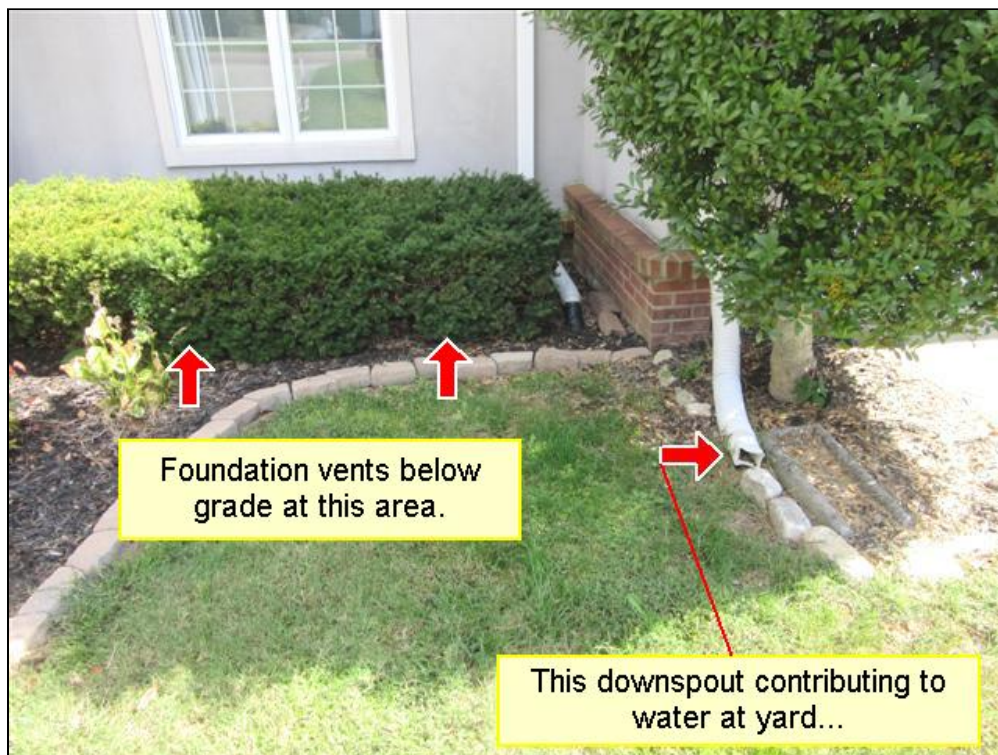
1.3 Item 3(Picture) Adjoining property owners gutter downspout may be contributing to water at crawlspace.

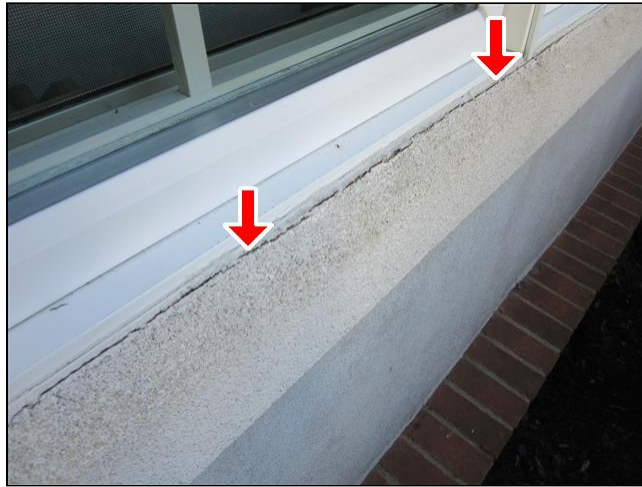
Many EIFS/Stucco systems installed in the 1990's have had moisture intrusion related problems that can not often be identified by a home inspection ,as the scope or full nature of the damage that these systems can cause would be outside the scope of most any inspection as many of these areas are covered ,not visible or would require removal of the wall covering itself to fully evaluate.

2.0 Item 1(Picture) Maintaining caulk at exterior with this type of exterior finish is critical.

A watertight seal or barrier is recommended with this type of siding and repairing any damaged / cracked areas at exterior and keeping windows and doors caulked with the appropriate sealer is highly recommended. Some cracks were noted and will need the correct type caulk or sealant used at these areas..

Caulking areas that are currently cracked or separated along with proper maintenance recommendations is imperative to minimize, and or prevent these problems and avoid costly repairs in the future.

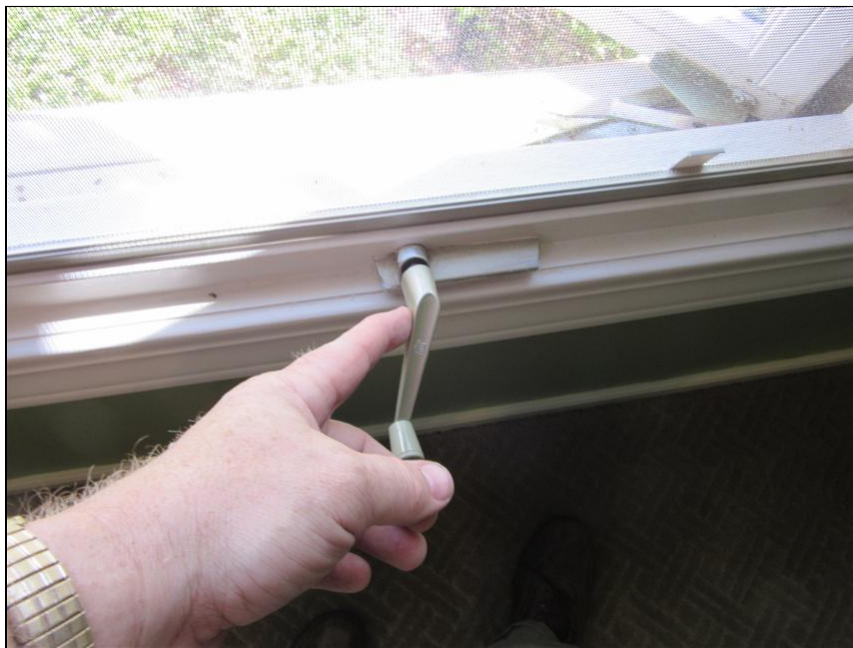
**2.2** Casement type windows are present some were stuck and were not opened or closed to prevent damaging the operating mechanism. At bedroom operating mechanism would not open close window ,it was closed manually. Recommend repair or replacement at window mechanism by qualified person ,then freeing stuck windows to determine their operating status.

2.2 Item 1(Picture) Damaged window opening mechanism.

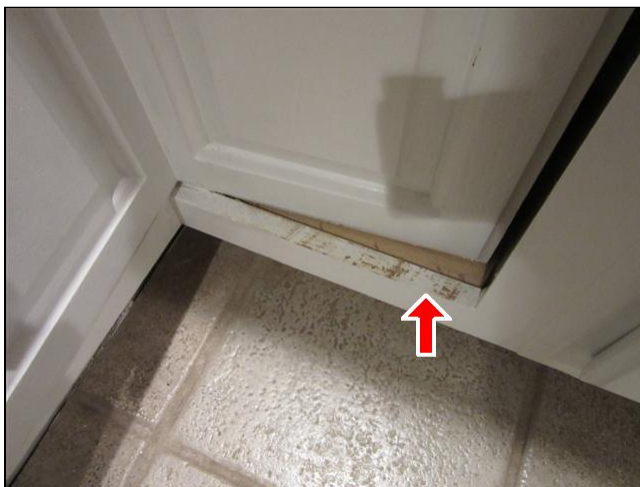
**4.4 Lazy susan door rubbing at bottom and may need minor adjustment.**

4.4 Item 1(Picture) Lazy susan door rubbing at bottom.

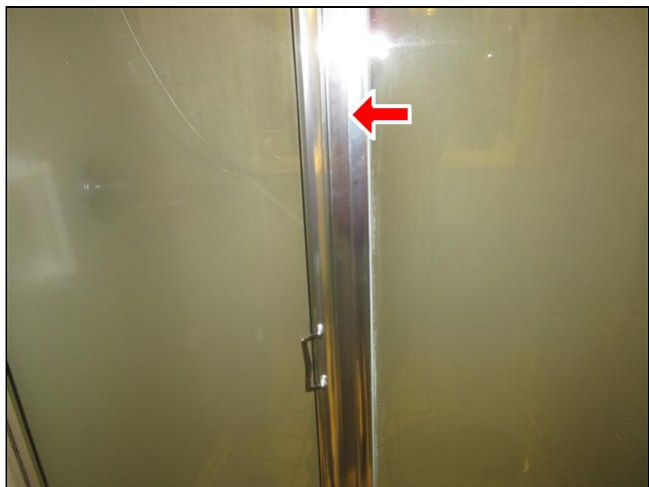
**4.5 Adjustment needed at shower door and medicine cabinet door. These should be minor repairs.**

4.5 Item 1(Picture) Shower door rubbing when operated.

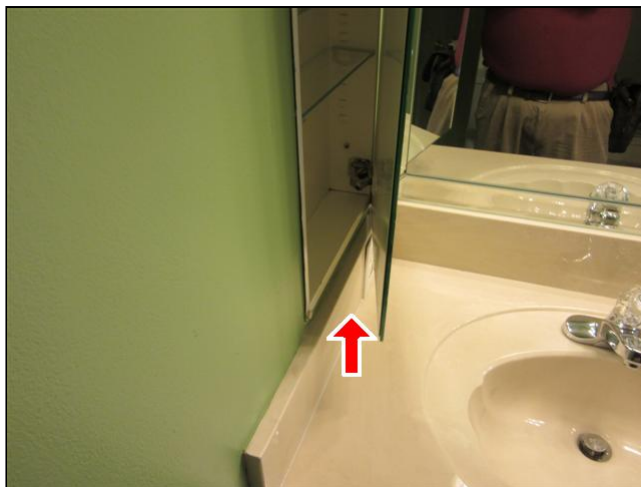
4.5 Item 2(Picture) Medicine cabinet door does not close properly.

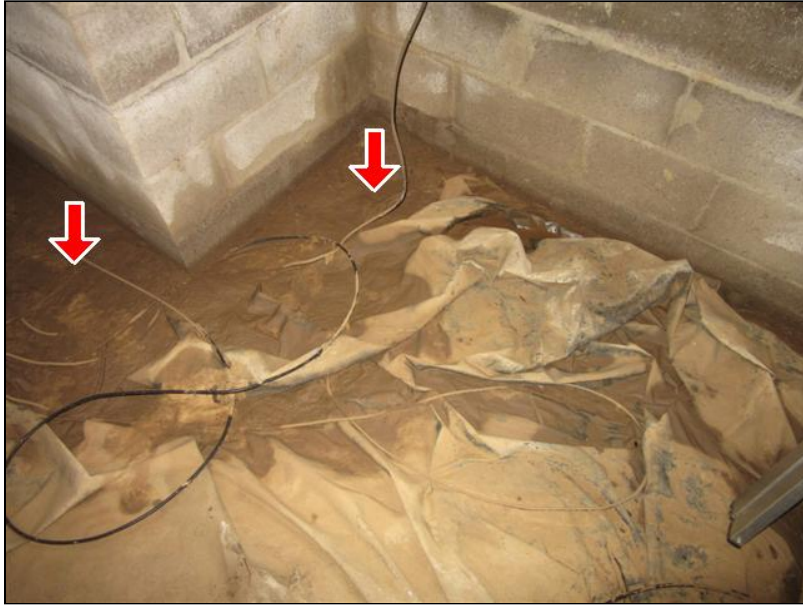
**5.0** Crawlspace had some growth consistent with mold or fungus at wood components within the crawlspace. Some water standing at plastic vapor barrier noted as well.. Contributing factors likely include foundation vents at front below grade, drain at crawlspace stopped up, gutter downspouts not properly routed or disconnected and loose or missing vapor barrier at crawlspace. Recommendations are made elsewhere individually in this report. Recommendations will aid in reducing humidity levels and in turn mold or fungus that can grow as a result.

5.0 Item 1(Picture) Some standing water noted at crawlspace.

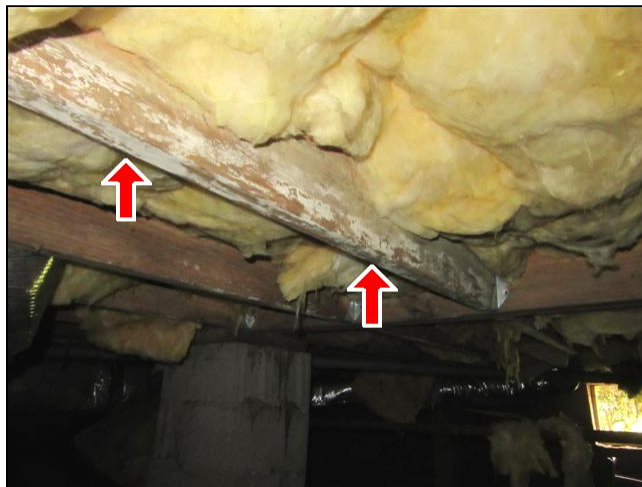
5.0 Item 2(Picture) Microbial growth noted at floor joist.

If you are concerned with mold, the Inspector recommends that you hire a specialist to perform further testing.

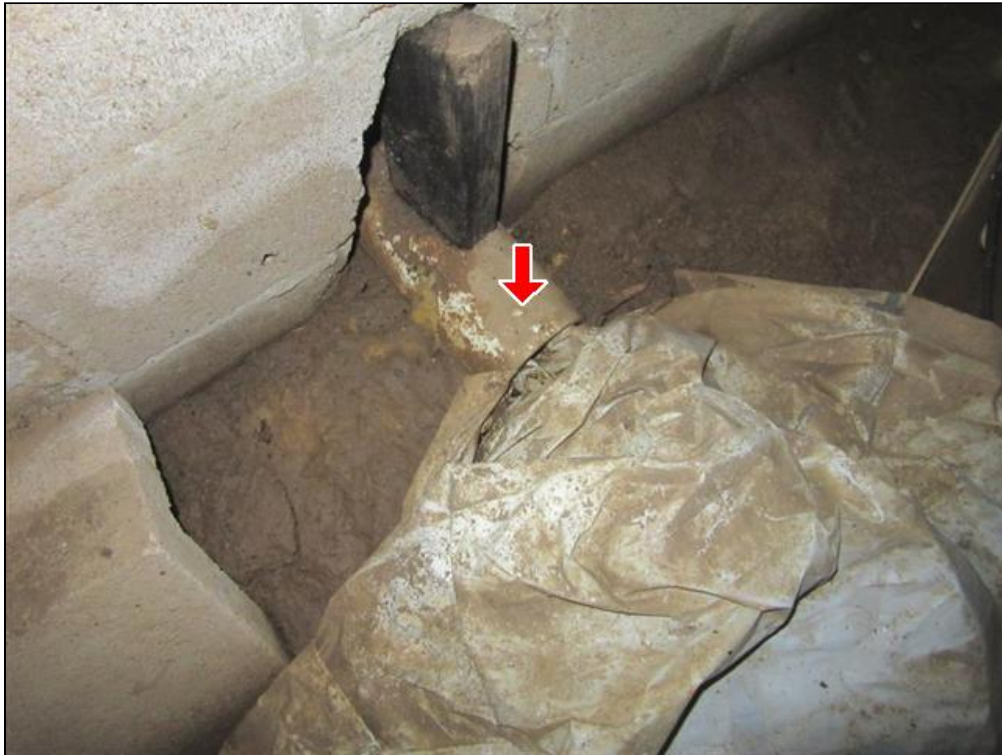
5.0 Item 3(Picture) Drain at crawlspace stopped up.

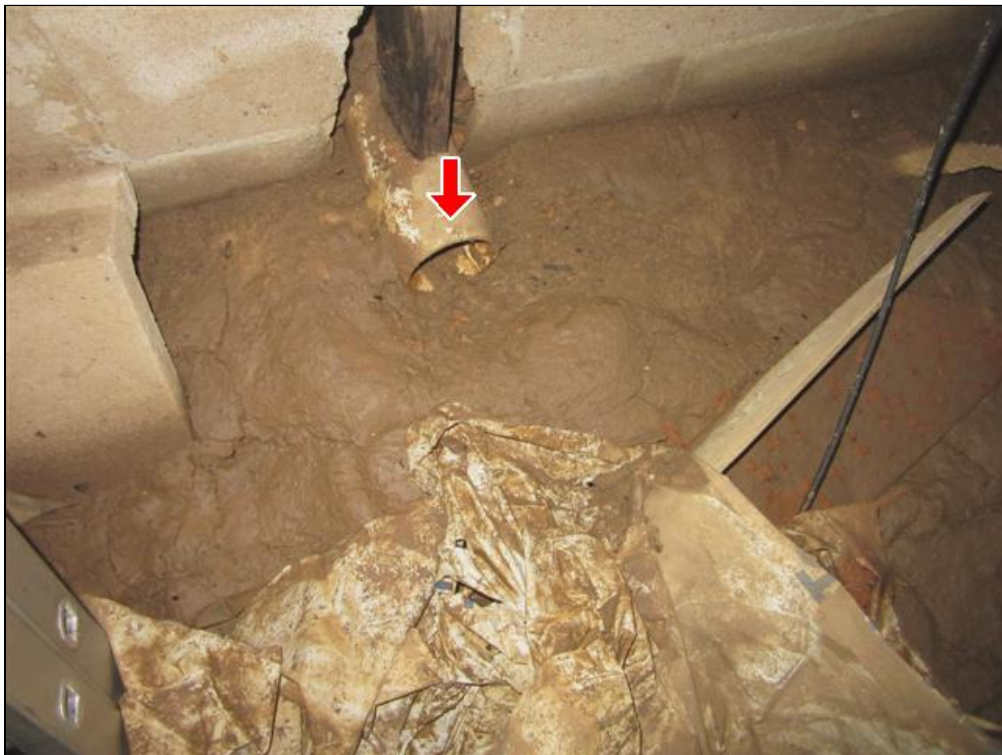
5.0 Item 4(Picture) Same drain after removing debris.

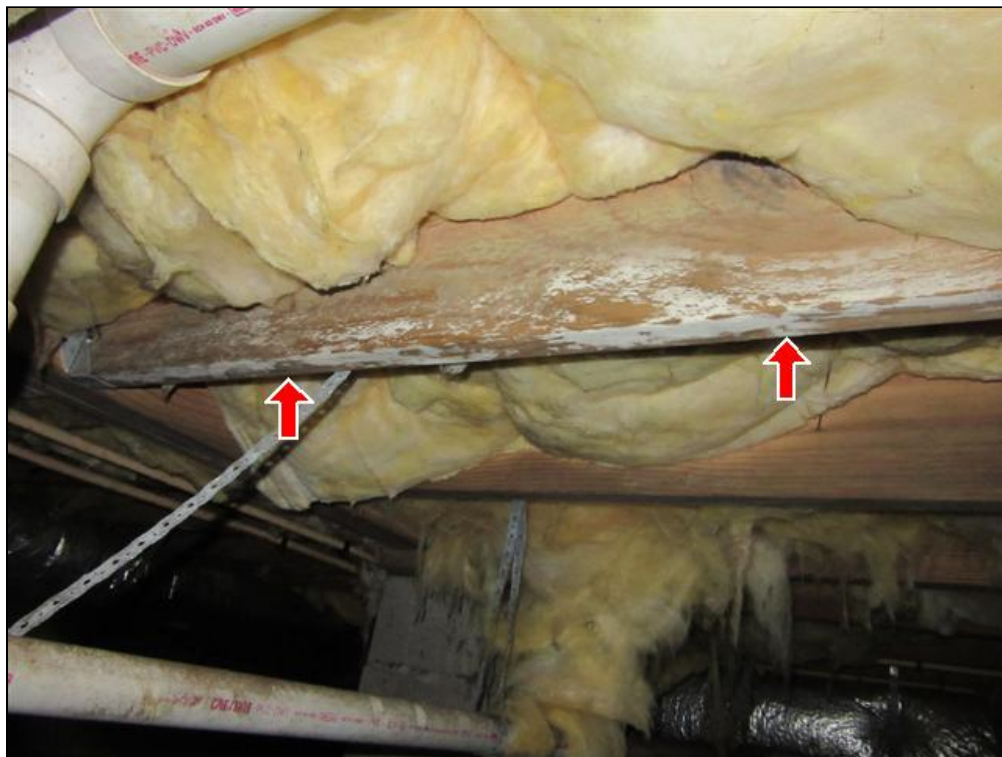
5.0 Item 5(Picture) Growth at floor joist..

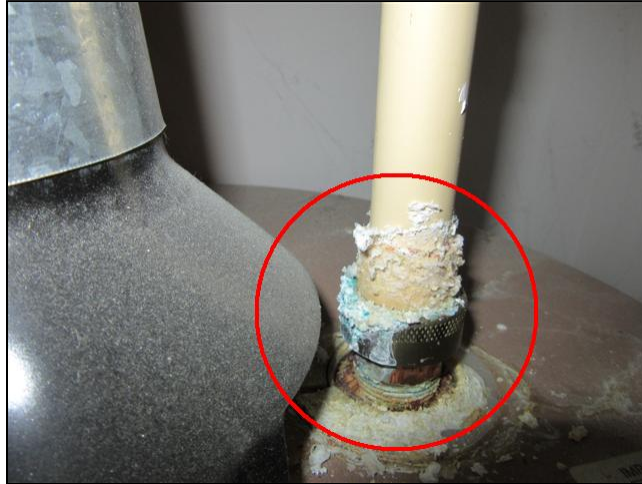
**6.1** Corrosion noted at cold water supply at water heater . This indicated a slow leak has been present. Recommend qualified person repair.

6.1 Item 1(Picture) Corrosion noted at hot water heater plumbing.

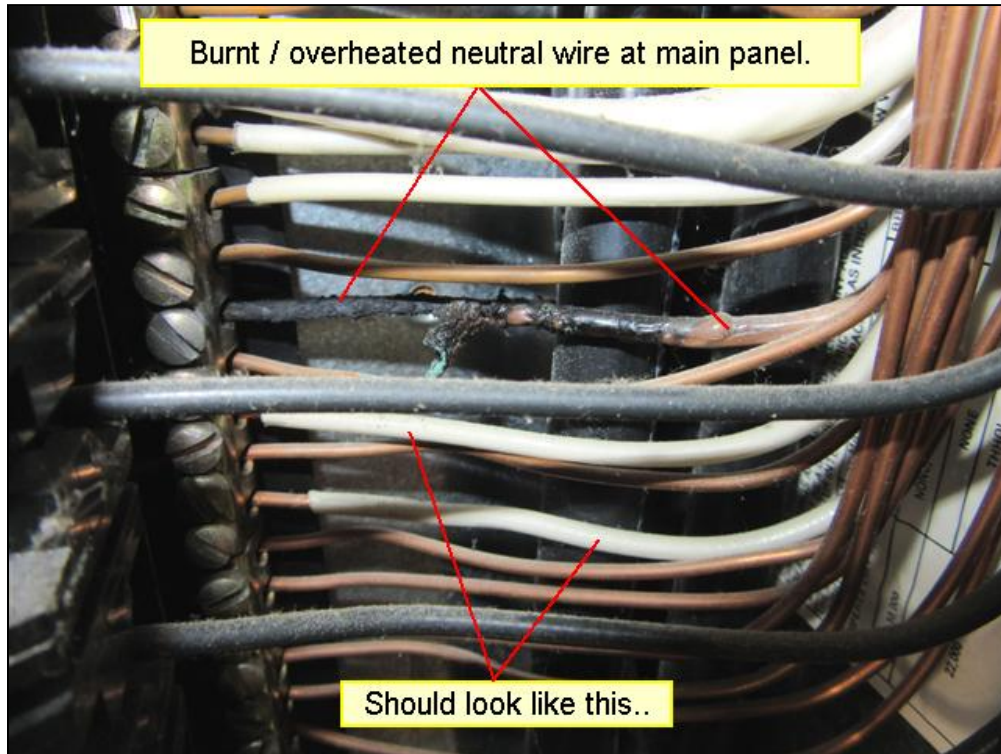
**7.2** At main panel a burnt / overheated neutral wire was noted. Recommend qualified person evaluate and repair.

7.2 Item 1(Picture) Overheated neutral wire noted at main panel.

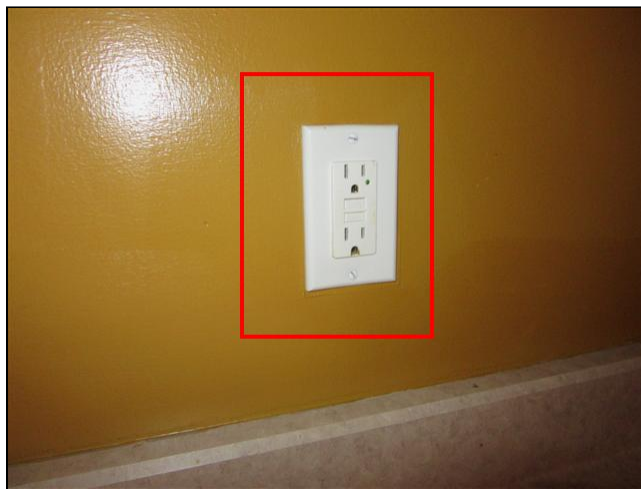
**7.5** GFCI type receptacle at kitchen would not trip when tested, recommend qualified person repair or replace.

7.5 Item 1(Picture) GFCI type receptacle would not trip when tested.(kitchen)

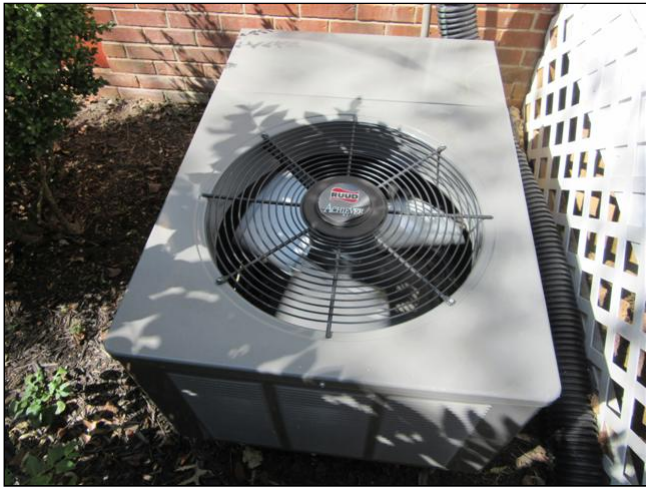
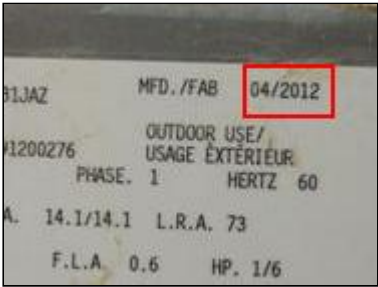
**8.8** A/C condenser is dirty and will need service to improve performance and improve efficiency.

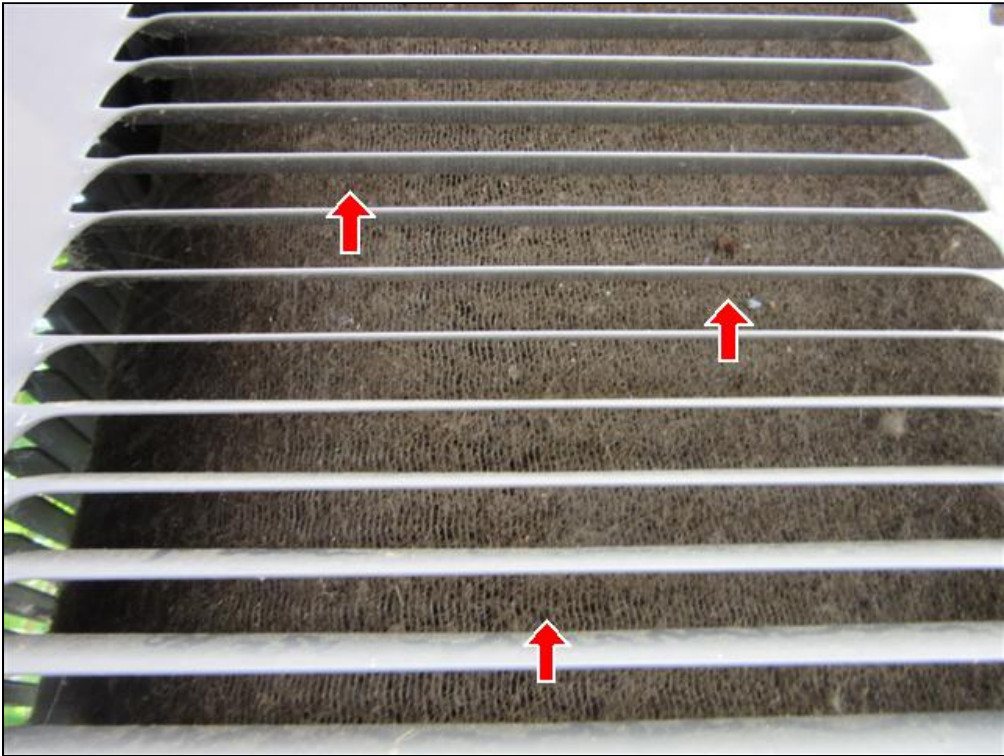
8.8 Item 3(Picture) Close up of A/C condenser fins.

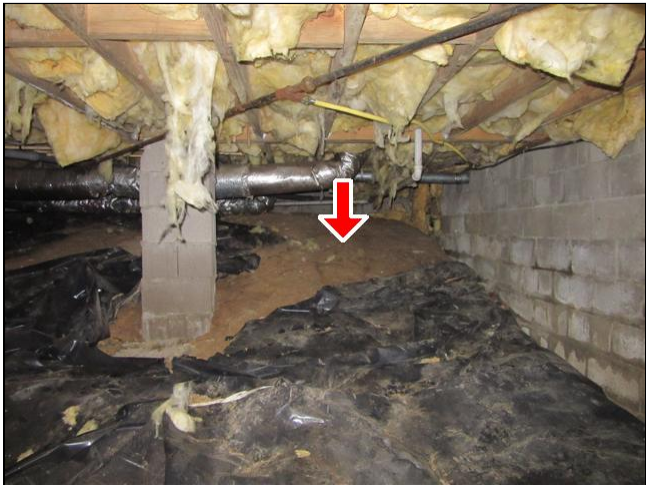
**9.2** Plastic vapor barrier at crawlspace floor is missing at areas. Recommend installing where missing to prevent moisture from entering these areas.

9.2 Item 1(Picture) Vapor barrier missing at places.

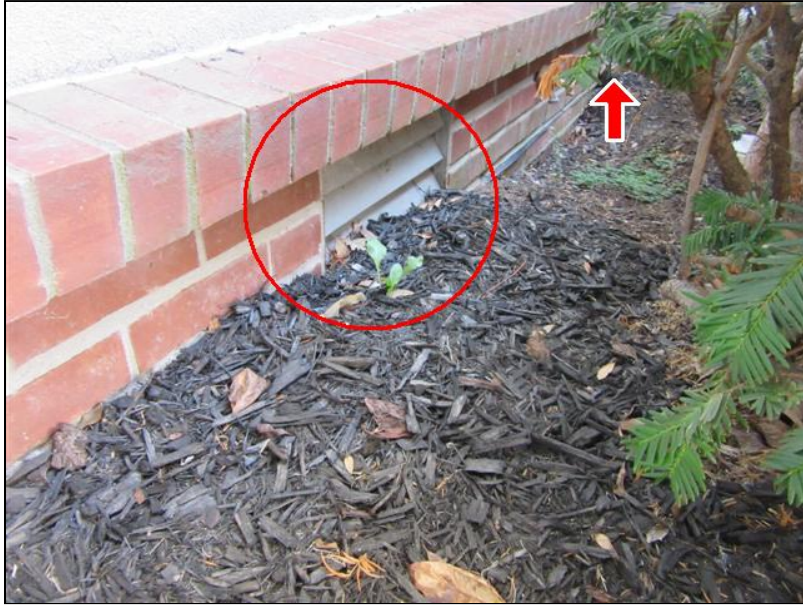
**🏠 9.3 Multiple foundation vents are at or near grade. This can allow water to enter if certain conditions are present i.e ,heavy rain, lack of gutters ,stopped up...overflowing gutters etc... Recommend repair by qualified person. This can include but is not limited to modifying the grade at this area and or installing "window wells" to prevent water from entering these areas.**

9.3 Item 1(Picture) Two foundation vents are below grade.

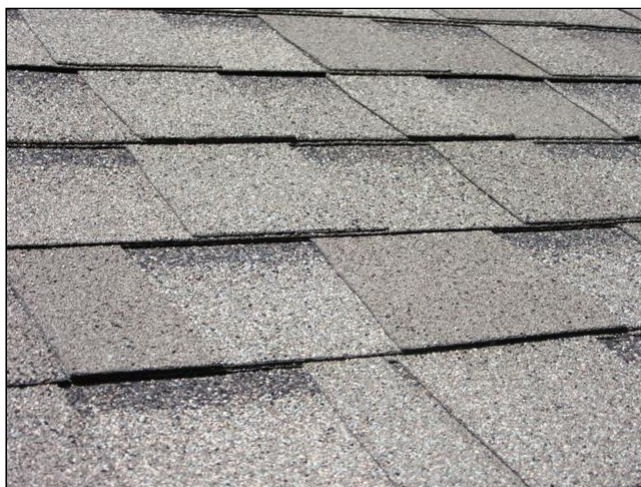
1.0 Item 3(Picture) Close up at rear.

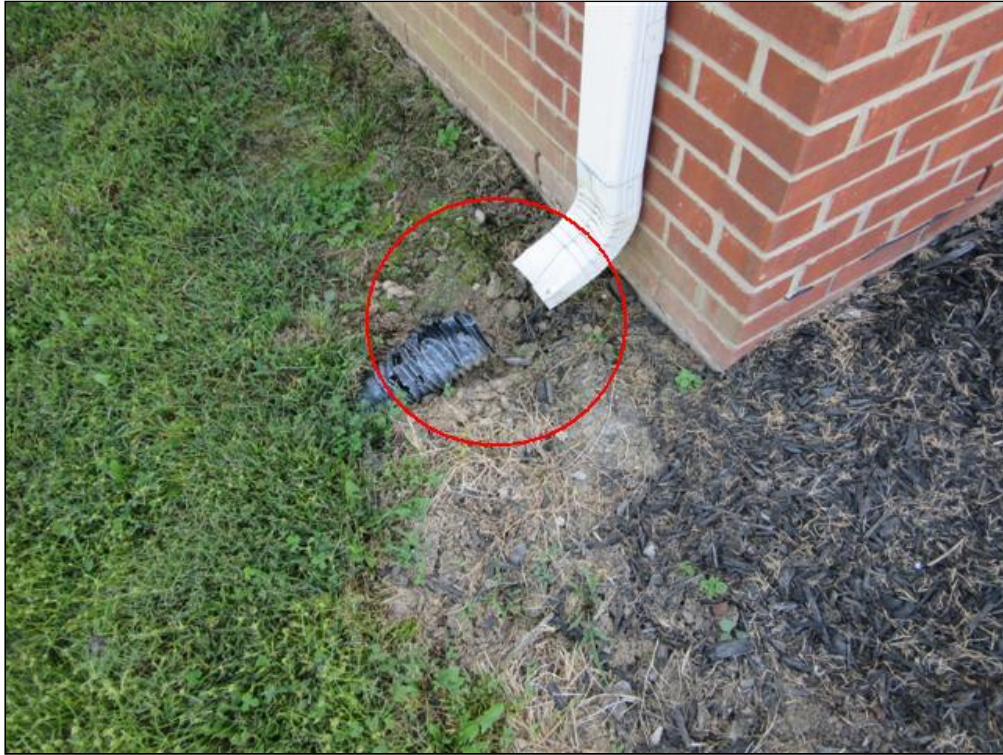
Gutter downspout extensions are recommended to help route excess rain water away from foundation. Some downspouts use an underground drain system and the areas where they terminate should be kept unobstructed to allow excess rain water to flow as intended.

1.3 Item 1(Picture) Downspout disconnected.

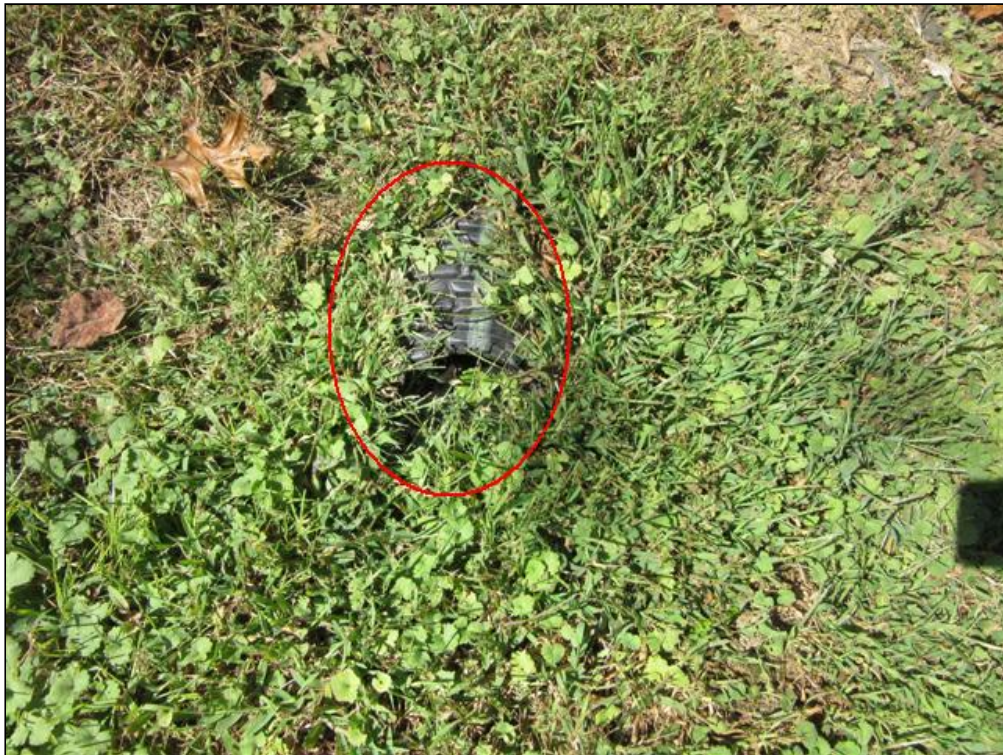
1.3 Item 2(Picture) Buried gutter downspouts should be opened and allow water to flow as intended.

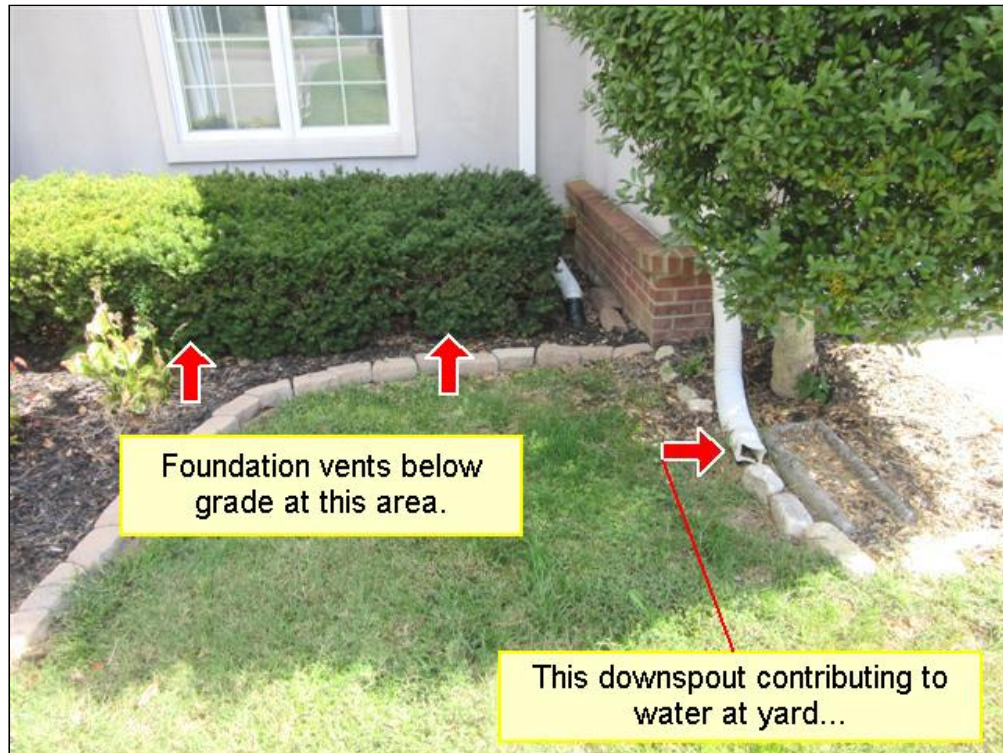
1.3 Item 3(Picture) Adjoining property owners gutter downspout may be contributing to water at crawlspace.

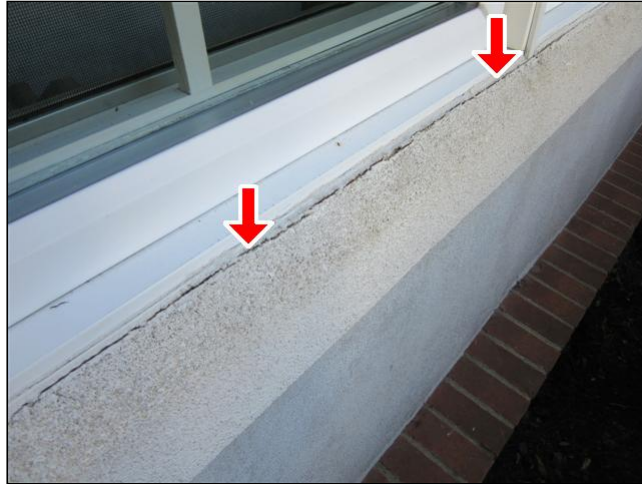
2.0 Item 1(Picture) Maintaining caulk at exterior with this type of exterior finish is critical.

Caulking areas that are currently cracked or separated along with proper maintenance recommendations is imperative to minimize, and or prevent these problems and avoid costly repairs in the future.

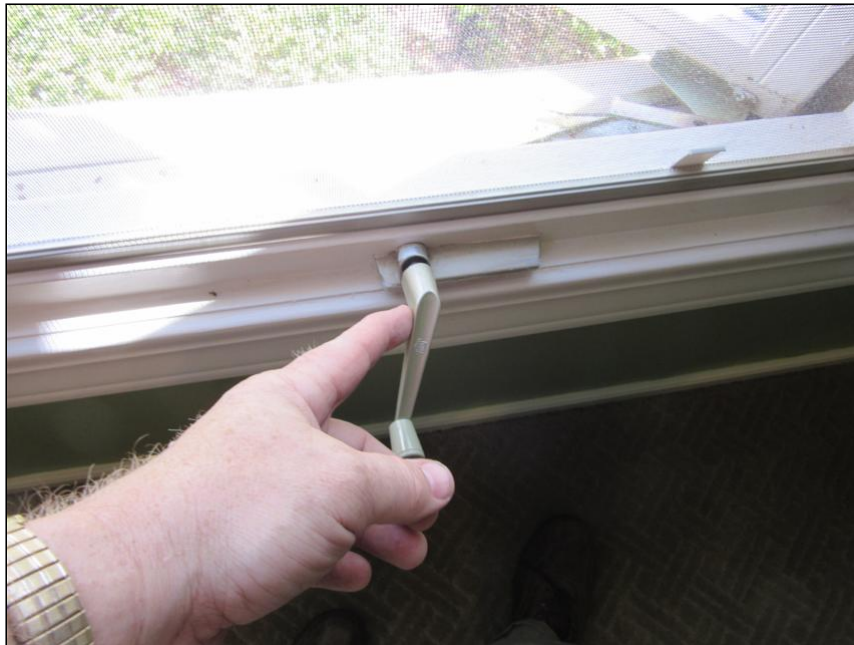
Casement type windows are present some were stuck and were not opened or closed to prevent damaging the operating mechanism. At bedroom operating mechanism would not open close window ,it was closed manually. Recommend repair or replacement at window mechanism by qualified person ,then freeing stuck windows to determine their operating status.

2.2 Item 1(Picture) Damaged window opening mechanism.

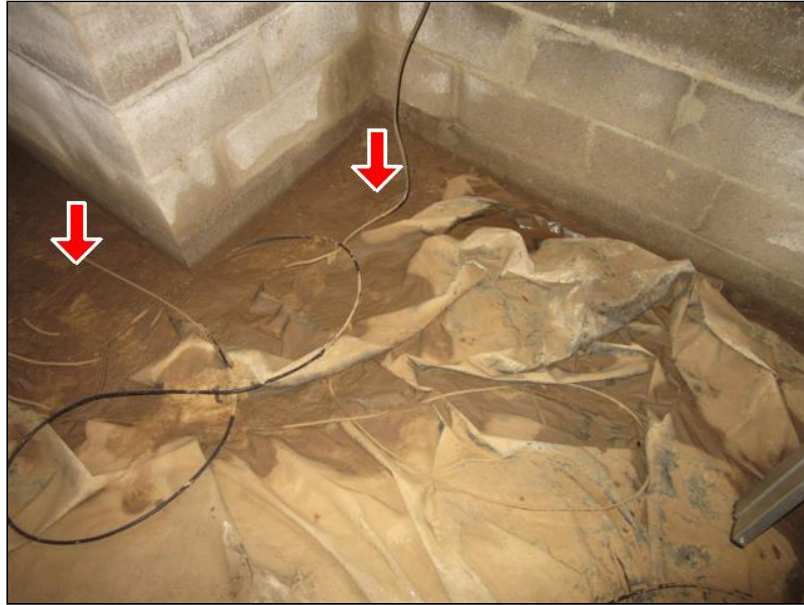
5.0 Item 1(Picture) Some standing water noted at crawlspace.

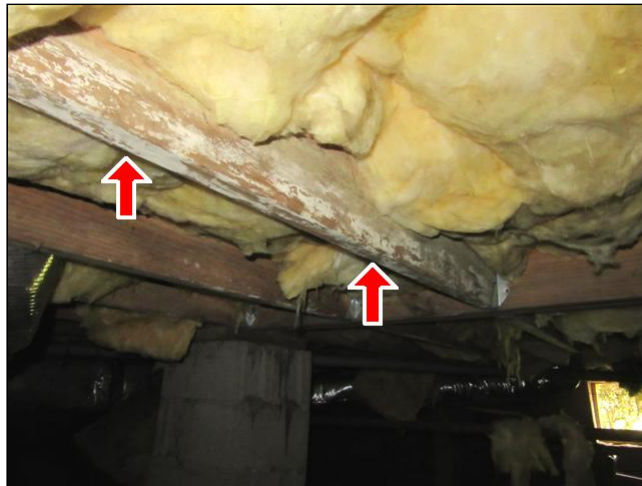
5.0 Item 2(Picture) Microbial growth noted at floor joist.

If you are concerned with mold, the Inspector recommends that you hire a specialist to perform further testing.

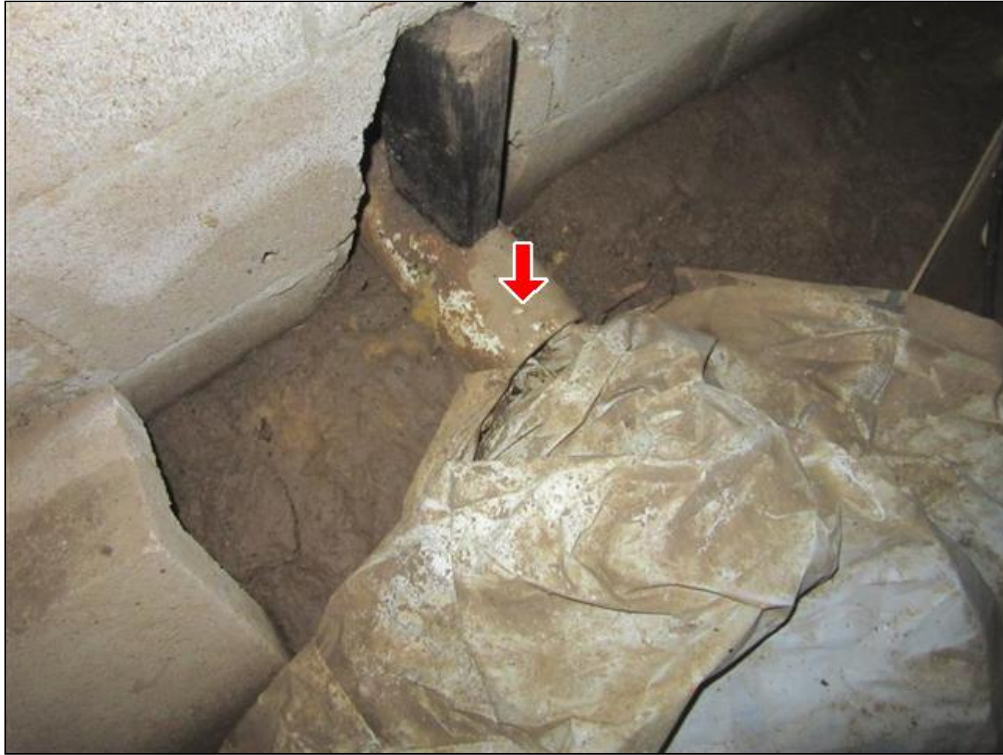
5.0 Item 3(Picture) Drain at crawlspace stopped up.

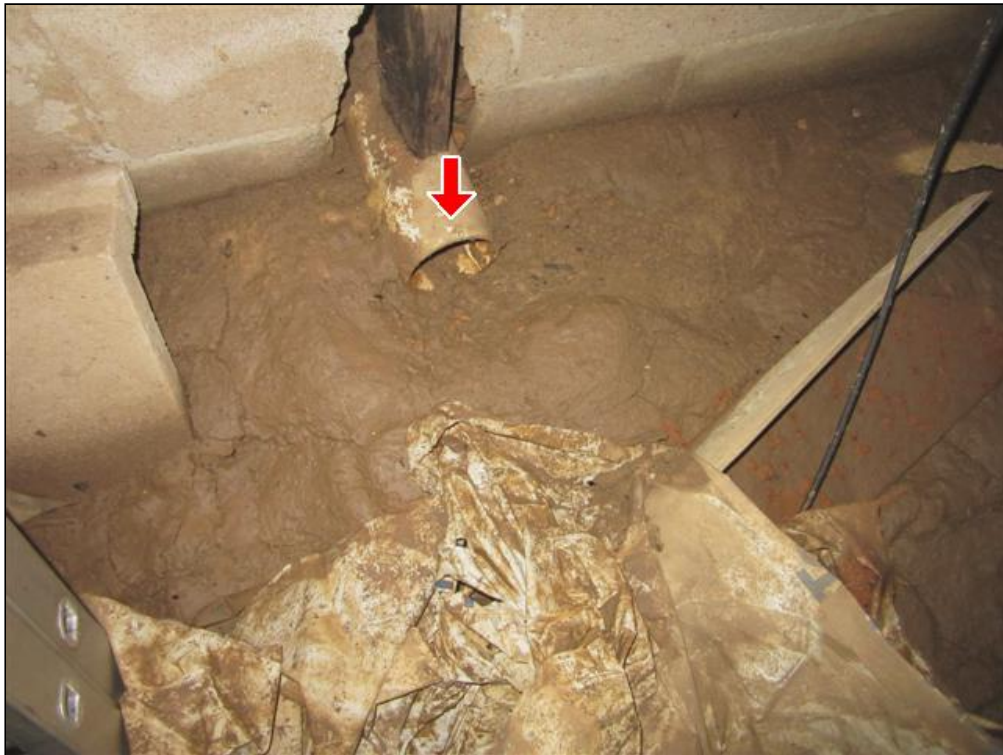
5.0 Item 4(Picture) Same drain after removing debris.

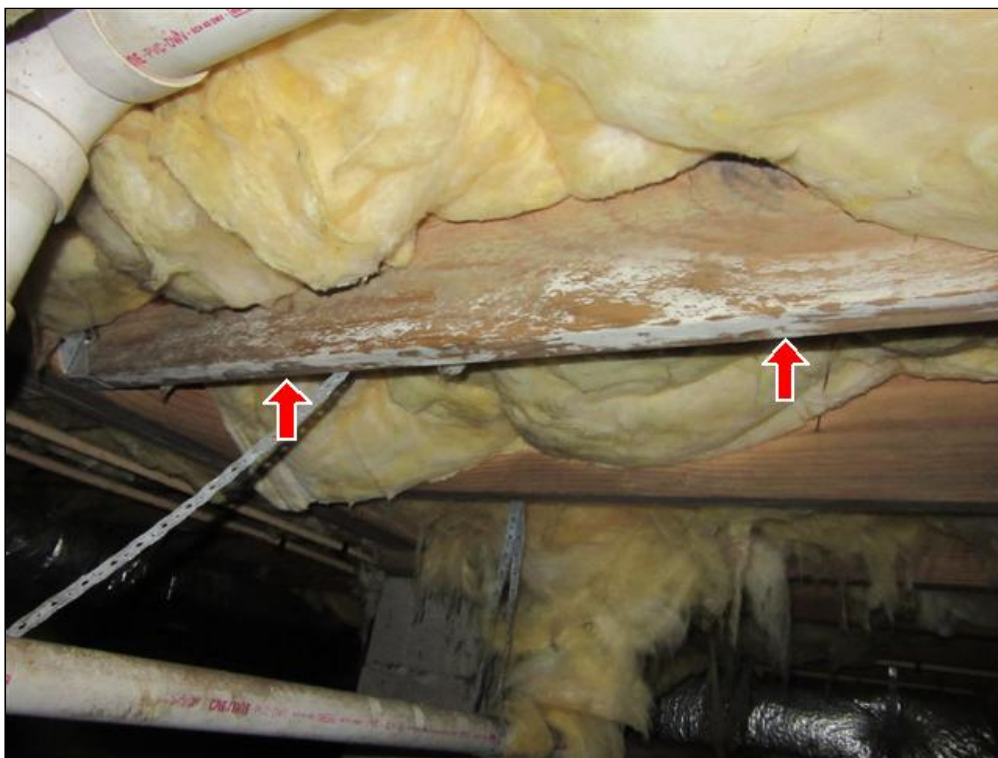
5.0 Item 5(Picture) Growth at floor joist..

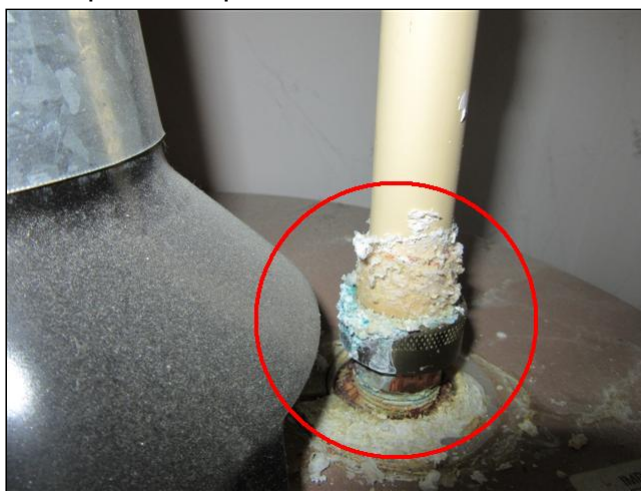
Corrosion noted at cold water supply at water heater . This indicated a slow leak has been present. Recommend qualified person repair.

6.1 Item 1(Picture) Corrosion noted at hat water heater plumbing.

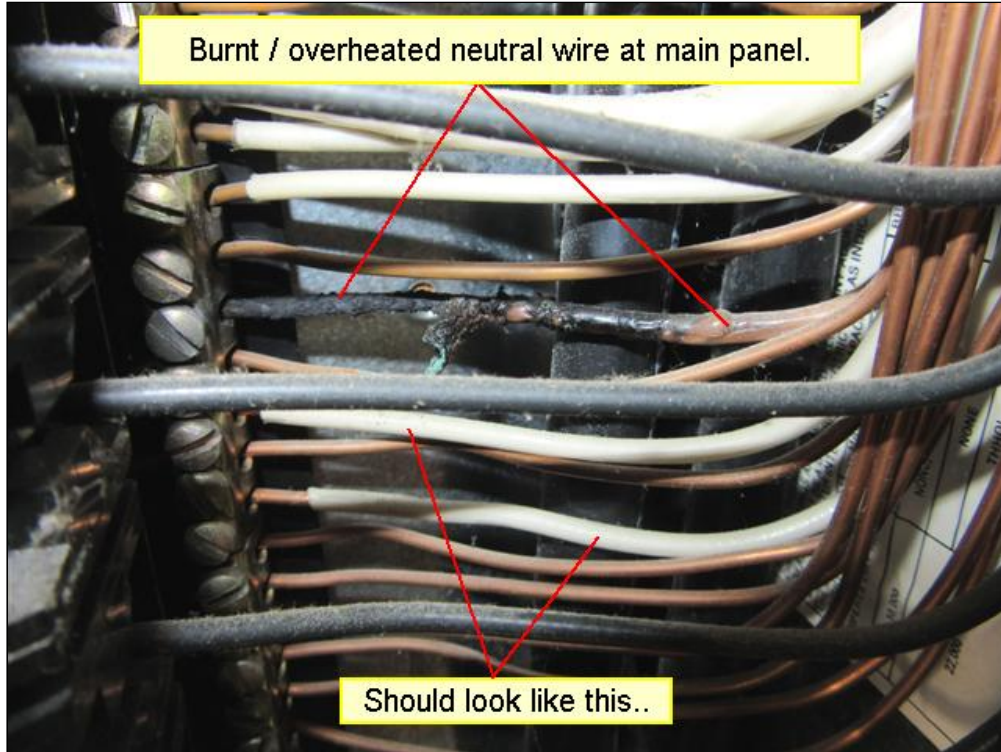
At main panel a burnt / overheated neutral wire was noted. Recommend qualified person evaluate and repair.

7.2 Item 1(Picture) Overheated neutral wire noted at main panel.

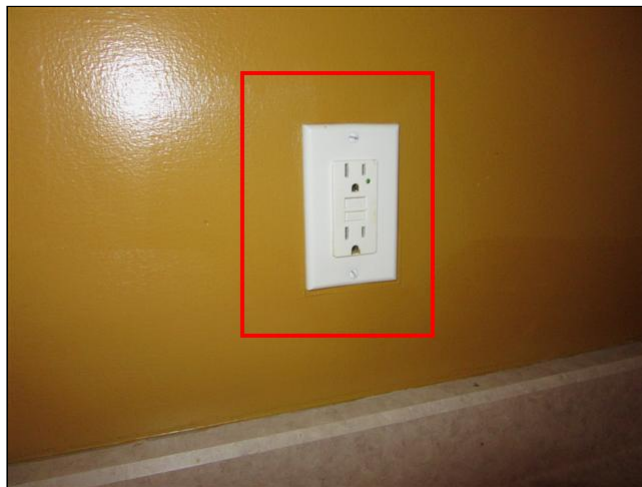
GFCI type receptacle at kitchen would not trip when tested, recommend qualified person repair or replace.

7.5 Item 1(Picture) GFCI type receptacle would not trip when tested.(kitchen)

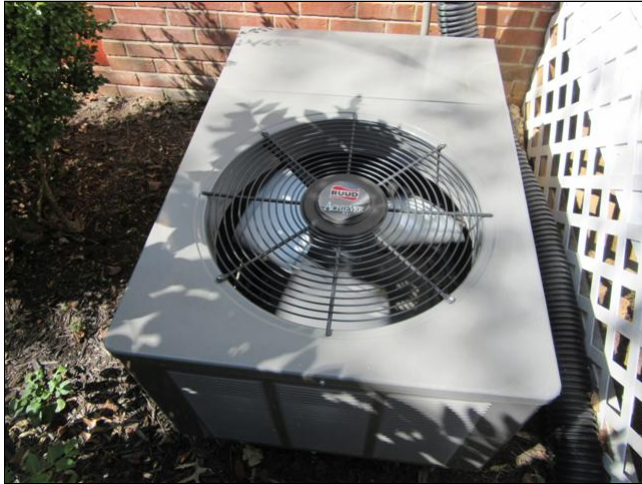
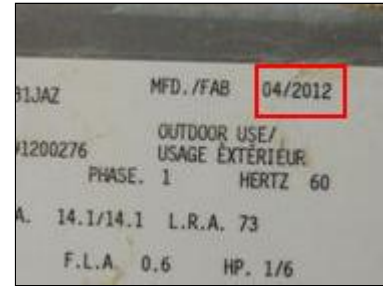
A/C condenser is dirty and will need service to improve performance and improve efficiency.

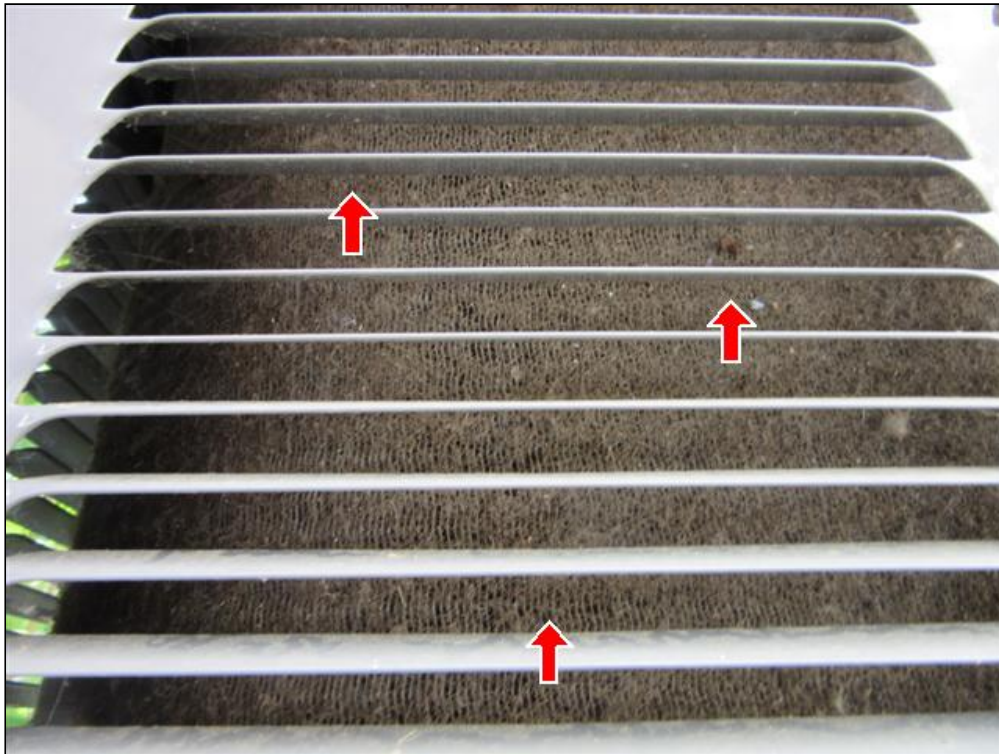
8.8 Item 3(Picture) Close up of A/C condenser fins.

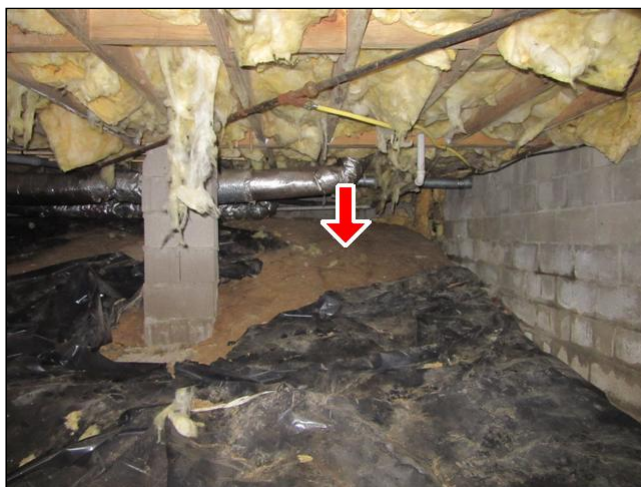
Plastic vapor barrier at crawlspace floor is missing at areas. Recommend installing where missing to prevent moisture from entering these areas.

9.2 Item 1(Picture) Vapor barrier missing at places.
