# Inspection Report

456 Sample Dr.  
Jackson Tn. 42066

**Town and Country Property Inspections**

<b>Date:</b> 9/24/2015	<b>Time:</b> 11:00 AM	<b>Report ID:</b> 092415
<b>Property:</b> 456 Sample Dr. Jackson Tn. 42066	<b>Customer:</b> Mr. and Mrs. John Smith	<b>Real Estate Professional:</b>

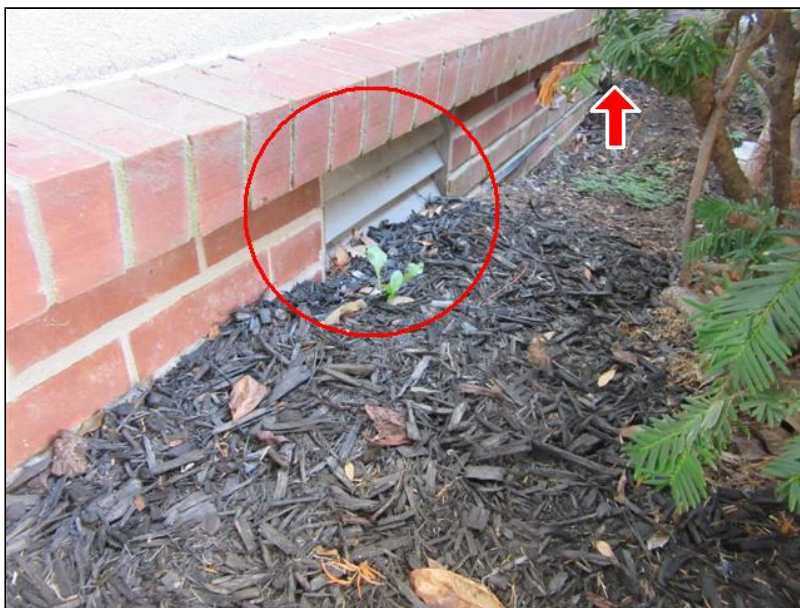
Multiple foundation vents are at or near grade. This can allow water to enter if certain conditions are present i.e ,heavy rain, lack of gutters ,stopped up...overflowing gutters etc... Recommend repair by qualified person. This can include but is not limited to modifying the grade at this area and or installing "window wells" to prevent water from entering these areas.

9.3 Item 1(Picture) Two foundation vents are below grade.
